ASBESTOS REFURBISHMENT SURVEY REPORT

Castletroy WWTP

Limerick CIP

Client	Irish Water
Project Title	23777 Limerick CIP (Bunlicky, Castletroy, Foynes & Glin) Asbestos Surveys
Document Title	Asbestos Refurbishment Report Castletroy WWTP
Report No.	23777/D

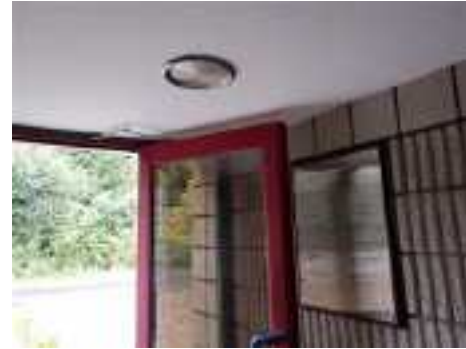
Location Details 289615 No Asbestos Found

Building/Area : Control Building
 Room/Section : Entrance
 Location : All Walls Floor and Ceiling
 Description : Solid and Plasterboard
 Sample No. :
 Confirmation : --N\A--
 Access : Full Access
 Normal Use :
 Recommendations :

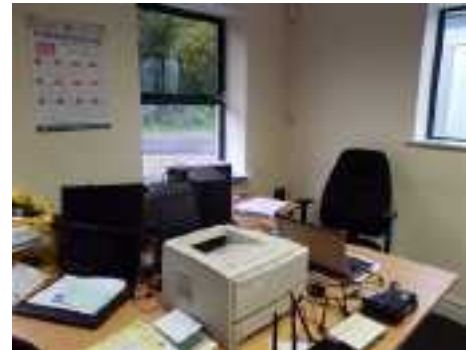
Location Details 289616 No Asbestos Found

Building/Area : Control Building
 Room/Section : Office
 Location : All Walls Floor and Ceiling
 Description : Solid and Plasterboard
 Sample No. :
 Confirmation : --N\A--
 Access : Full Access
 Normal Use :
 Recommendations :

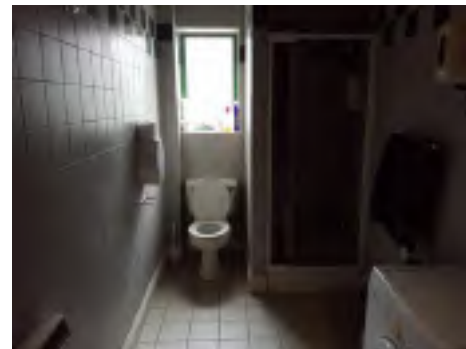
Location Details 289617 No Asbestos Found

Building/Area : Control Building
 Room/Section : Toilet
 Location : All Walls Floor and Ceiling
 Description : Solid and Plasterboard
 Sample No. :
 Confirmation : --N\A--
 Access : Full Access
 Normal Use :
 Recommendations :

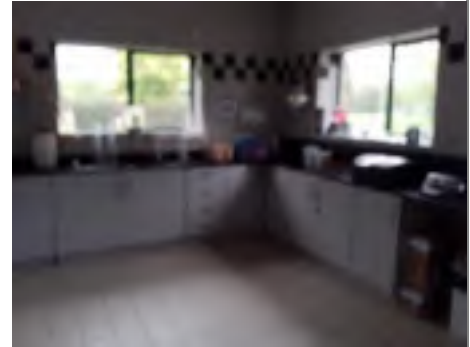
Location Details 289618 No Asbestos Found

Building/Area : Control Building
 Room/Section : Laboratory
 Location : All Walls Floor and Ceiling
 Description : Solid and Plasterboard
 Sample No. :
 Confirmation : --N\A--
 Access : Full Access
 Normal Use :
 Recommendations :

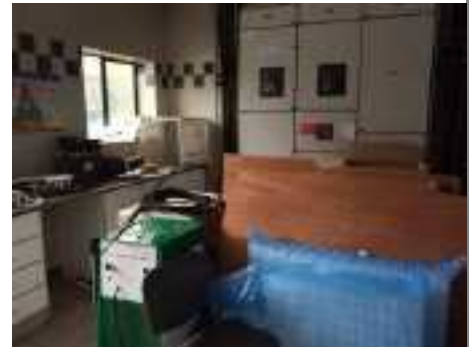
Location Details 289619 No Asbestos Found

Building/Area : Control Building
 Room/Section : Canteen
 Location : All Walls Floor and Ceiling
 Description : Solid and Plasterboard
 Sample No. :
 Confirmation : --N\A--
 Access : Full Access
 Normal Use :
 Recommendations :

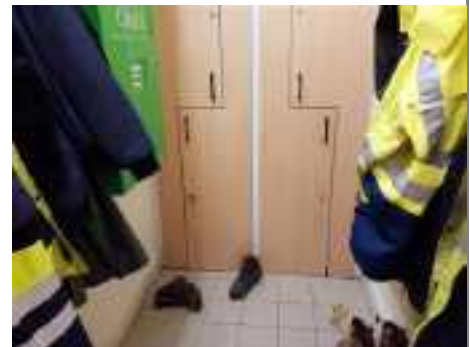
Location Details 289620 No Asbestos Found

Building/Area : Control Building
 Room/Section : Locker Room
 Location : All Walls Floor and Ceiling
 Description : Solid and Plasterboard
 Sample No. :
 Confirmation : --N\A--
 Access : Full Access
 Normal Use :
 Recommendations :

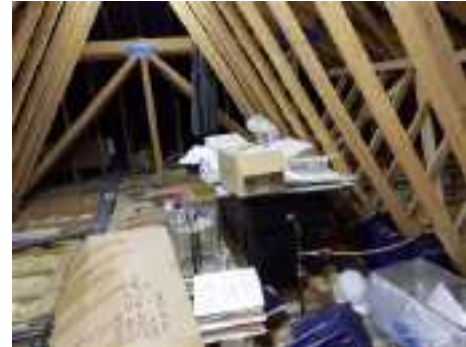
Location Details 289621 No Asbestos Found

Building/Area : Control Building
 Room/Section : Attic
 Location : All Walls Floor and Ceiling
 Description : Solid and Plasterboard
 Sample No. :
 Confirmation : --N\A--
 Access : Full Access
 Normal Use :
 Recommendations :

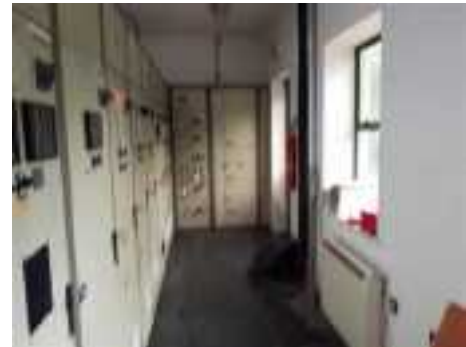
Location Details 289622 No Asbestos Found

Building/Area : Control Building
 Room/Section : Electrical Room
 Location : All Walls Floor and Ceiling
 Description : Solid and Plasterboard
 Sample No. :
 Confirmation : --N\A--
 Access : Full Access
 Normal Use :
 Recommendations :

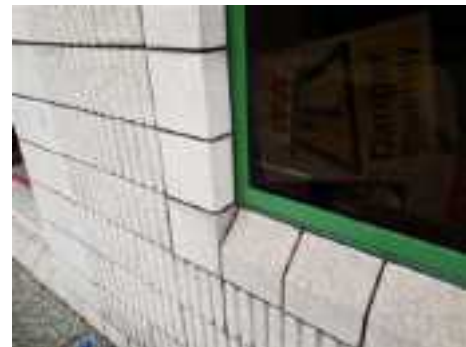
Location Details 289623 No Asbestos Found

Building/Area : Control Building
 Room/Section : Facade
 Location : Windows
 Description : Putty
 Sample No. : AMB20180501001
 Confirmation : Sample Taken
 Access : Full Access
 Normal Use :
 Recommendations :

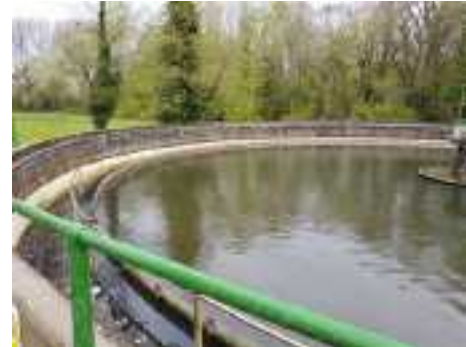
Location Details 289624 No Asbestos Found

Building/Area : Tanks
 Room/Section :
 Location : All Walls and Floor
 Description : Solid and Tiled
 Sample No. :
 Confirmation : --N\A--
 Access : Full Access
 Normal Use :
 Recommendations :

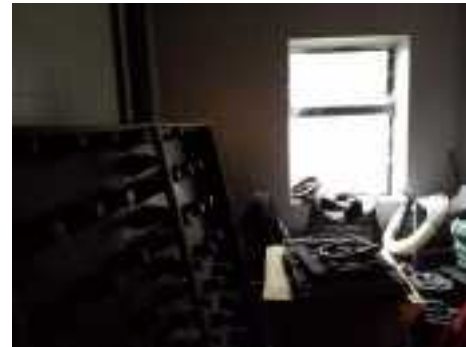
Location Details 289625 No Asbestos Found

Building/Area : Bell Press
 Room/Section : Ground Floor Store
 Location : All Walls and Floor
 Description : Solid and Tiled
 Sample No. :
 Confirmation : --N\A--
 Access : Full Access
 Normal Use :
 Recommendations :

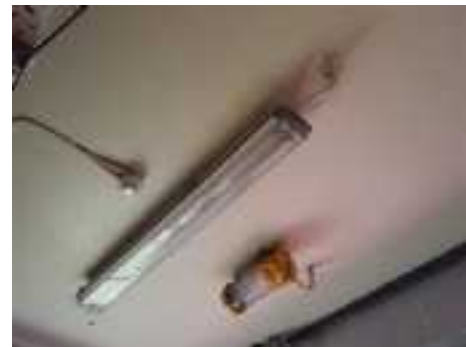
Location Details 289626 No Asbestos Found

Building/Area : Bell Press
 Room/Section : Ground Floor Store
 Location : Ceiling
 Description : Stipple
 Sample No. : AMB20180514001
 Confirmation : Sample Taken
 Access : Full Access
 Normal Use :
 Recommendations :

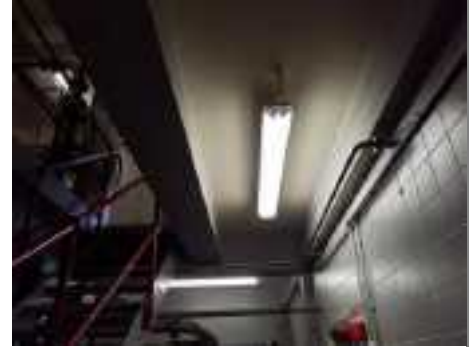
Location Details 289627 No Asbestos Found

Building/Area : Bell Press
Room/Section : Ground Floor Stairwell
Location : Ceiling
Description : Stipple
Sample No. : AMB20180514002
Confirmation : Sample Taken
Access : Full Access
Normal Use :
Recommendations :

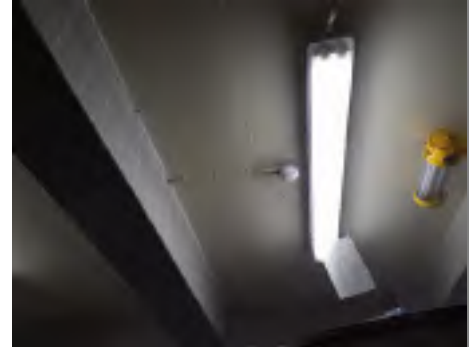
Location Details 289628 No Asbestos Found

Building/Area : Bell Press
Room/Section : Ground Floor Chemical Room
Location : Ceiling
Description : Stipple
Sample No. : AMB20180514003
Confirmation : Sample Taken
Access : Full Access
Normal Use :
Recommendations :

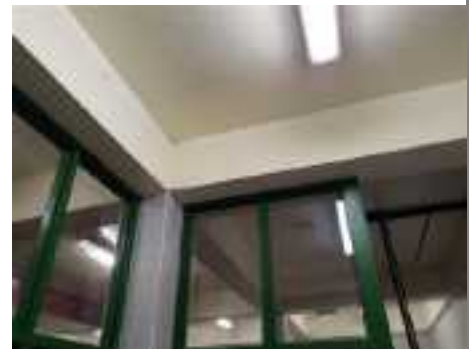
Location Details 289629 No Asbestos Found

Building/Area : Bell Press
Room/Section : 1st Floor Press Room
Location : Ceiling
Description : Stipple
Sample No. : AMB20180514004
Confirmation : Sample Taken
Access : Full Access
Normal Use :
Recommendations :

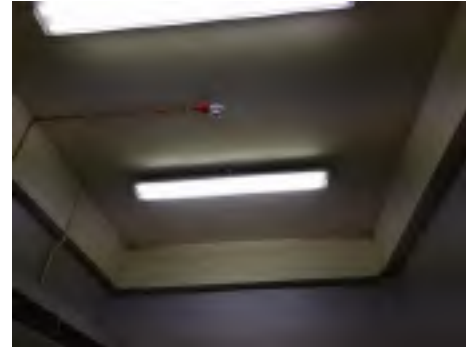
Location Details 289630 No Asbestos Found

Building/Area : Bell Press
 Room/Section : 1st Floor Control Room
 Location : Ceiling
 Description : Stipple
 Sample No. : AMB20180514005
 Confirmation : Sample Taken
 Access : Full Access
 Normal Use :
 Recommendations :

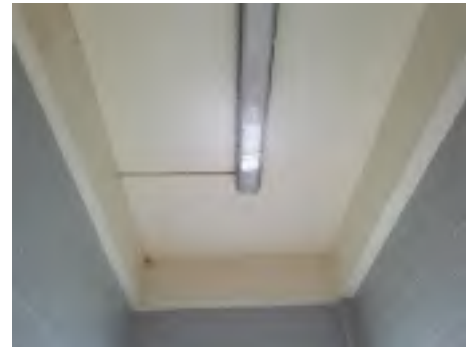
Location Details 289631 No Asbestos Found

Building/Area : Bell Press
 Room/Section : 1st Floor Toilet
 Location : Ceiling
 Description : Stipple
 Sample No. : AMB20180514006
 Confirmation : Sample Taken
 Access : Full Access
 Normal Use :
 Recommendations :

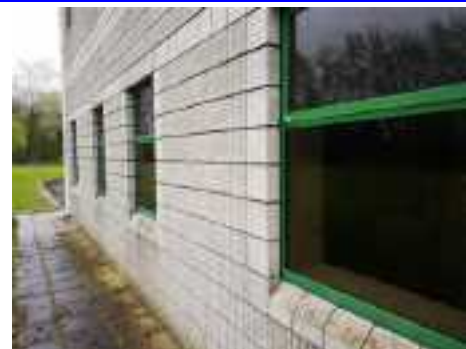
Location Details 289632 No Asbestos Found

Building/Area : Bell Press
 Room/Section : Facade
 Location : Windows
 Description : Putty
 Sample No. : AMB20180501004
 Confirmation : Sample Taken
 Access : Full Access
 Normal Use :
 Recommendations :

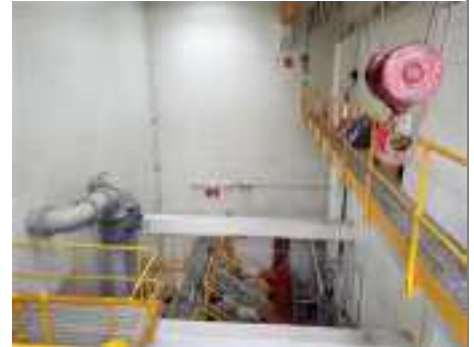
Location Details 289633 No Asbestos Found

Building/Area : Intake
 Room/Section :
 Location : All Walls Floor and Ceiling
 Description : Solid
 Sample No. :
 Confirmation : --N\A--
 Access : Full Access
 Normal Use :
 Recommendations :

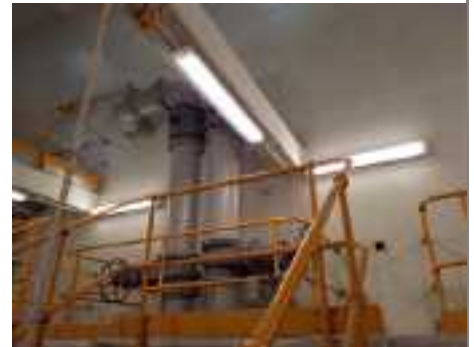
Location Details 289634 No Asbestos Found

Building/Area : Intake
 Room/Section :
 Location : All Walls Floor and Ceiling
 Description : Solid
 Sample No. :
 Confirmation : --N\A--
 Access : Full Access
 Normal Use :
 Recommendations :
