Greater Dublin Drainage

Alternative Sites Assessment and Route Selection Report (Phase 4): Final Preferred Site and Routes

Appendix 8 Soils and Geology

June 2013

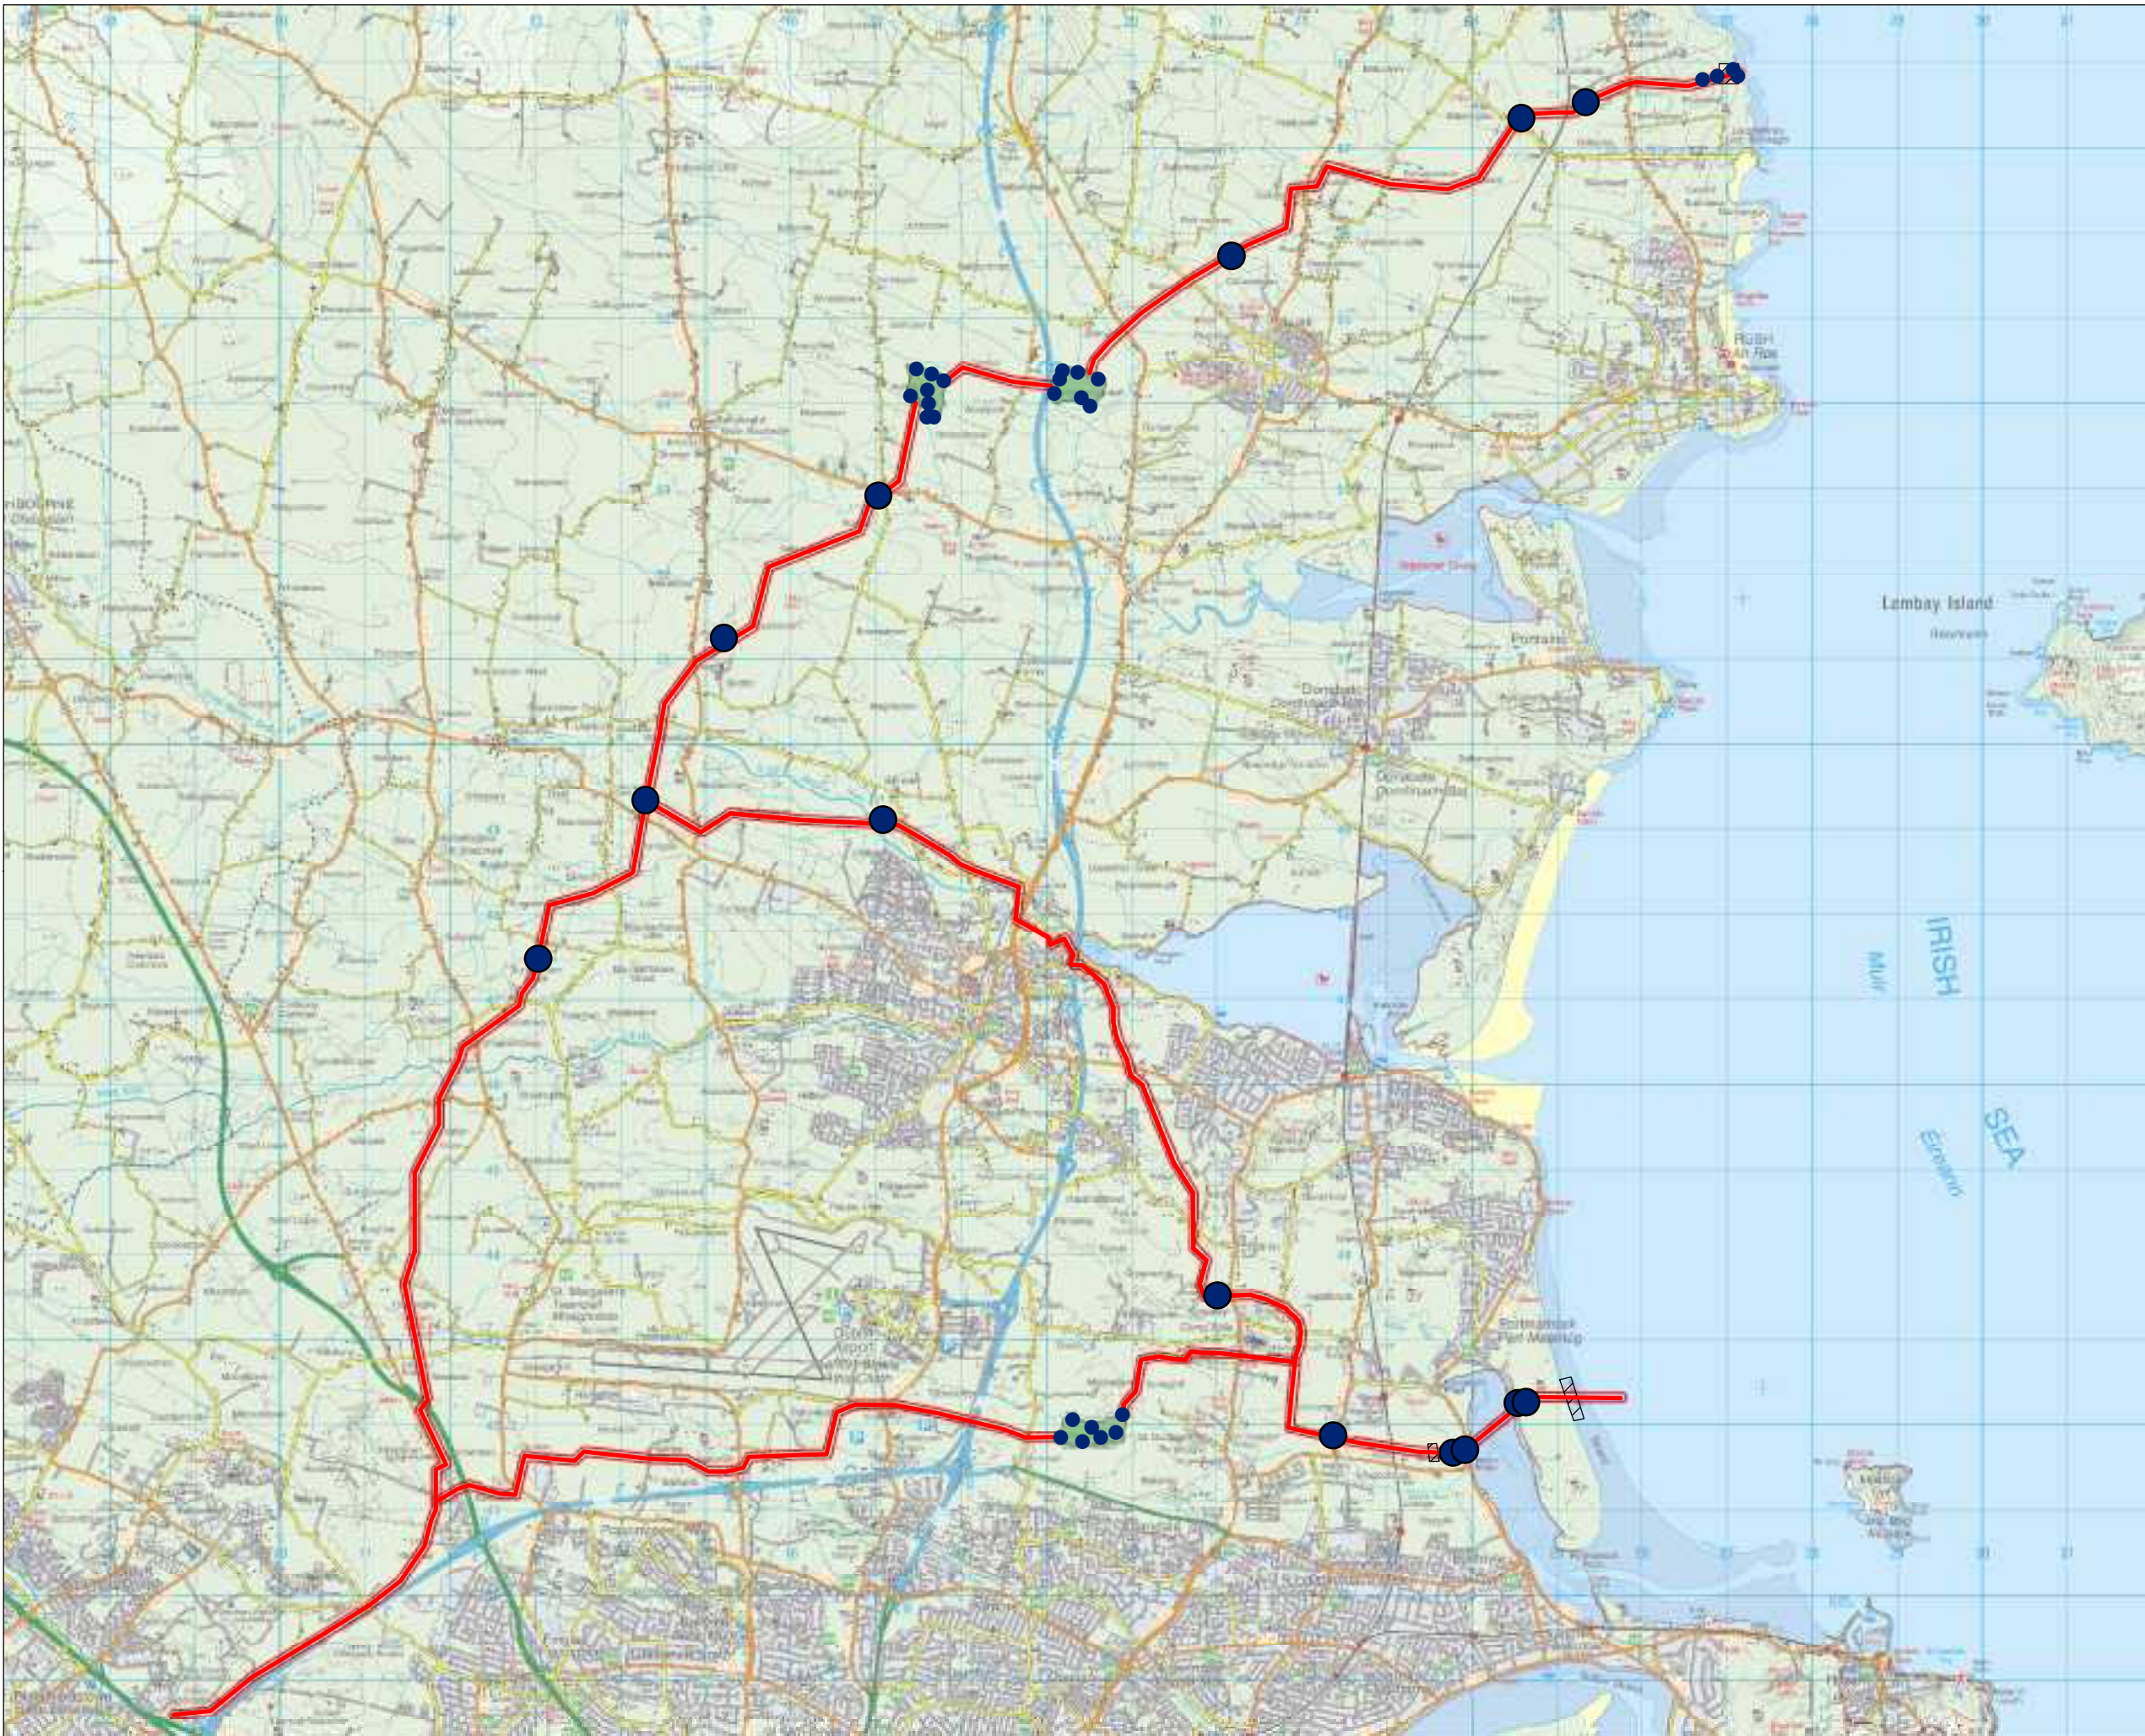
Job No 218525-00	Drawing Status For Information
Drawing No G-001	Issue P1

Drawing G001 – G013 – Preliminary Phase 1 Ground Investigation Locations
