## SECTION 10: Archaeology, Architectural and Cultural Heritage

This section presents the findings of an archaeological and cultural heritage impact assessment on the site of the Proposed Development of the Castletroy Wastewater Treatment Plant (WwTP) at Dromroe townland in Castletroy, Co. Limerick (ITM 560696, 658505; ). The site measures 3.166 hectares and is located within a Conservation Area as marked on *Map 7.7.4 Castletroy* on the Limerick County Council Development Plan 2010–2016. The location of the site is located adjacent to the Lower River Shannon and within the floodplains associated with it. The river was an important waterway since antiquity.

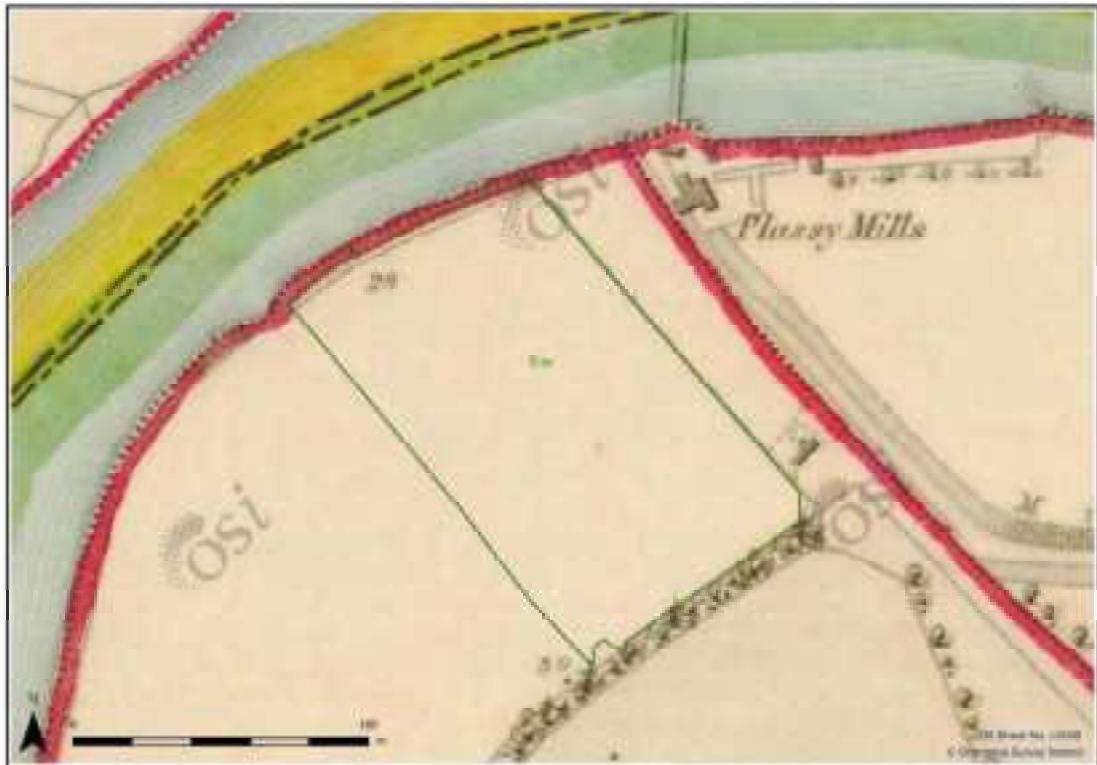
Figure 10-3: Extract from 1st Edition Ordnance Survey (OS) map (surveyed in 1839 - published 1844), showing location of site.

The cartographic review of the Ordnance Survey maps of 1839 (Figure 10-3) and 1900 (Figure 10-4) shows the site largely unchanged, adjacent and to the south of the Lower River Shannon and within agricultural land. Overall, it appears that the urbanisation of Castletroy to the south of the site did not commence until the mid-19th century. The 1st Edition OS map of 1839-44 shows the site as adjacent and north of demesne lands associated with Plassy Estate in Sreelane townland.

The site is separated from it with a wide band of trees. The east and north boundaries are also townland boundaries, with Sreelane to the west and the bank of the Lower River Shannon to the north. On the 1839-44 map, the site consists of a part of a large field with a long rectangular field along the east boundary of the site. Within the southeast corner, a T-shape building is shown with paths surrounding it. To the north of the site the pier is shown running half the width of the Lower River Shannon, connecting with the north side of the river via ferry. More detail is given on the 1900-02 map. The site is shown as bounded from south by a wet ditch, and the field boundary within the site is shown as a wet ditch also. Along the east extent of the site F.P (footpath) is labelled, and the mills labelled as Plassy Mills (Corn) are visibly extended, with additional features such as Foot Bridge and Foot Stick illustrated. It appears that the pier is now a bridge, labelled as Plassy Bridge and continues across the river. The south shore of the river is depicted as steep.

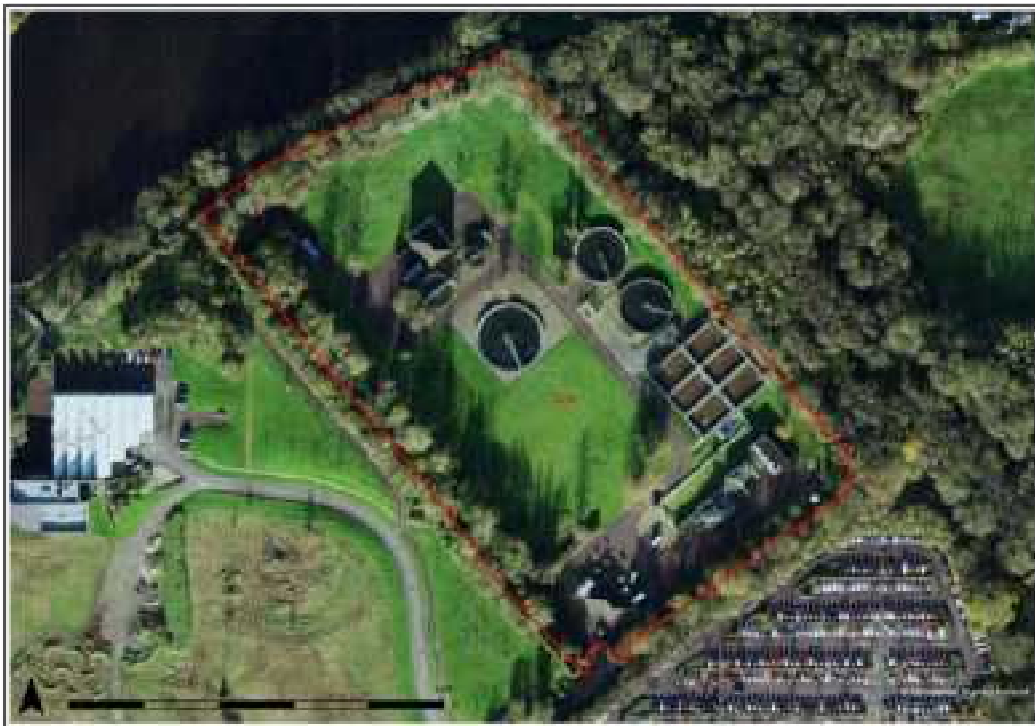
**Figure 10-5: Aerial view, showing location of site.**

On the 1995 aerial, the site is in use as a wastewater treatment plant, with additional clarifiers added sometime before 2010. The site remains largely unchanged since, however, some groundworks and/or clearing took place in the northwest part of the site in 2018.

The site is surrounded by fencing and is well screened by hedges and mature trees from all sides (Figure 10-5). Access to the site is via a security gate from the southwest corner. The access road leads to the northwest part of the site, curving around an administration/common room building, with ample parking space, and leads northwest passing aeration cells and clarifiers No. 1 and 2 to the west. The road splits leading to the Sludge dewatering Plant House; and along the ticker tanks to the existing final effluent and storm water outfall chamber located within the very northwest portion of the site.

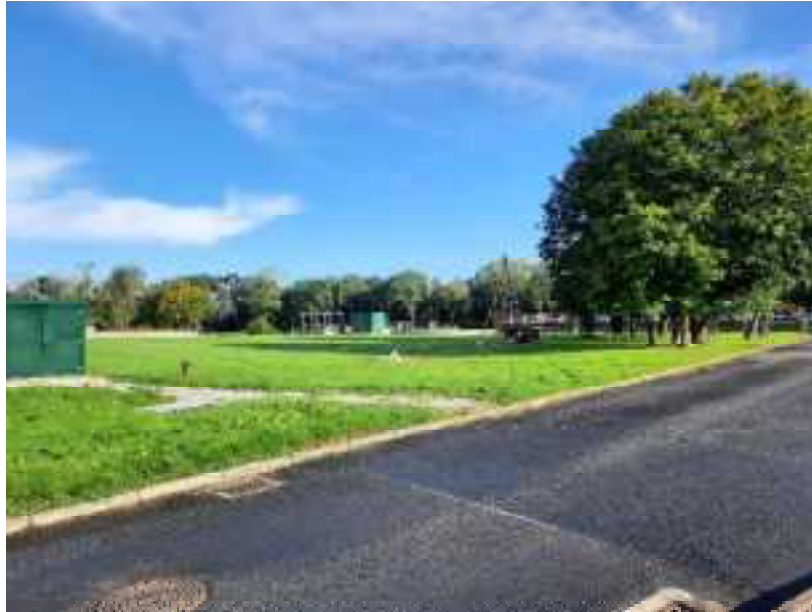
**Figure 10-6: Location of the proposed stormwater storage tank, facing north.**

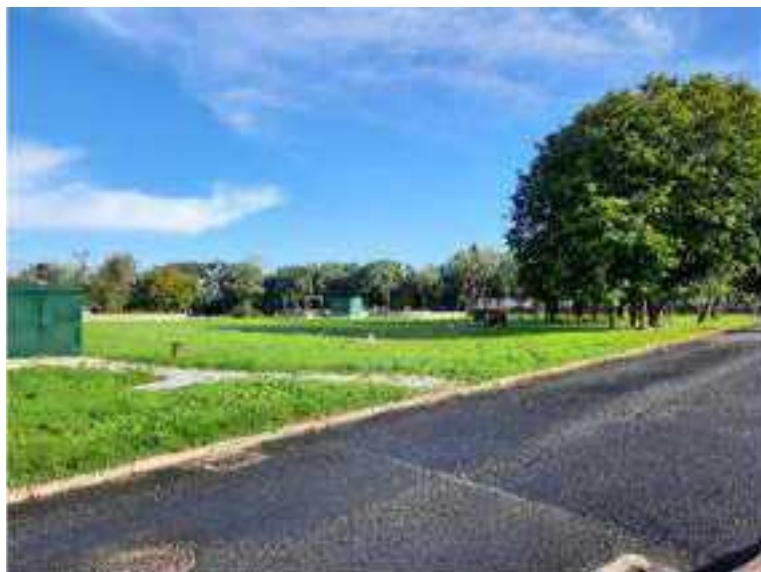
**Figure 10-7: Location of the proposed storm tank facing north**

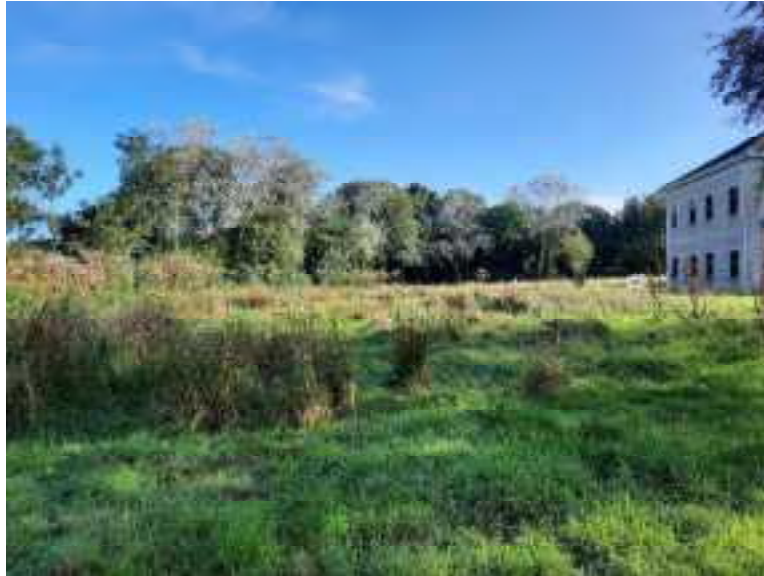
**Figure 10-8: North extent of the site, view towards Plassy Mills, facing east.**

Groundworks are proposed in the area adjacent to the Sludge Dewatering Plant House (Figure 10-8) and to the east of it with the majority of work concentrated within the central grassed levelled area, where a stormwater tank with associated infrastructure as well as overflow pipeworks and new access are proposed (Figure 10-7). The Protected Structure Plassy Mills (RPS 1600; NIAH Reg. 21900504) and Plassy Bridge (RPS ID 1599; NIAH Reg. No. 21900503) were not visible from the site due to dense tree cover.
